**Region 9 Enforcement Division
75 Hawthorne Street
San Francisco, CA 94105**

Inspection Date(s):	9/30/2015		
Time:	Entry: 8:45	Exit: 10:30	
Media:	Water		
Regulatory Program(s)	Clean Water Act NPDES /CAFO Dairy		
Company Name:	Northview Dairy		
Facility or Site Name:			
Facility/Site Physical Location:	Ex. 6 Personal Privacy (PP)		
Geographic Coordinates:			
Mailing address:	Ex. 6 Personal Privacy (PP)	Ontario, Ca, 91761	
Facility/Site Contact:	Daryl Koops	Title: Operator	
	Phone: Ex. 6 Personal Privacy (PP)	Email:	
Facility/Site Identifier:	NPDES CAG018001 / Order R8-2013-0001, General waste discharge requirements for CAFOs (dairies and related facilities)		
NAICS:	112120 Dairy Cattle and Milk Production		
SIC:	0241 Dairy Farms		
Facility/Site Personnel Participating in Inspection:			
Name	Affiliation	Title	Email
Daryl Koops		Operator	
EPA Inspector(s):			
John Tinger	EPA	Engineer	Tinger.John@EPA.gov
Federal/State/Tribal/Local Representatives:			
Edward Kashak	WRCB-R8	Engineering Geologist	ekashak@waterboards.ca.gov

SECTION I – INTRODUCTION

I.1 Purpose of the Inspection

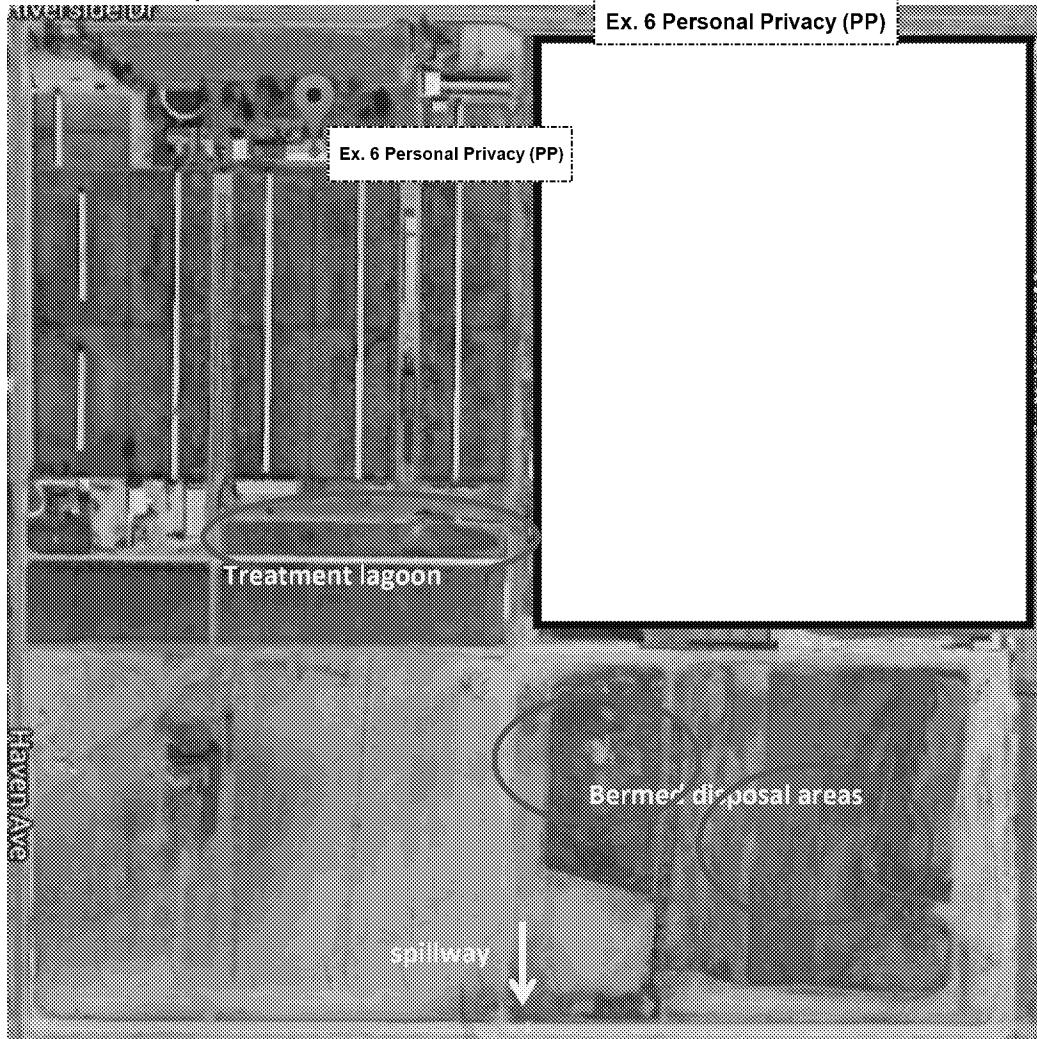
Photo 1 Facility overview

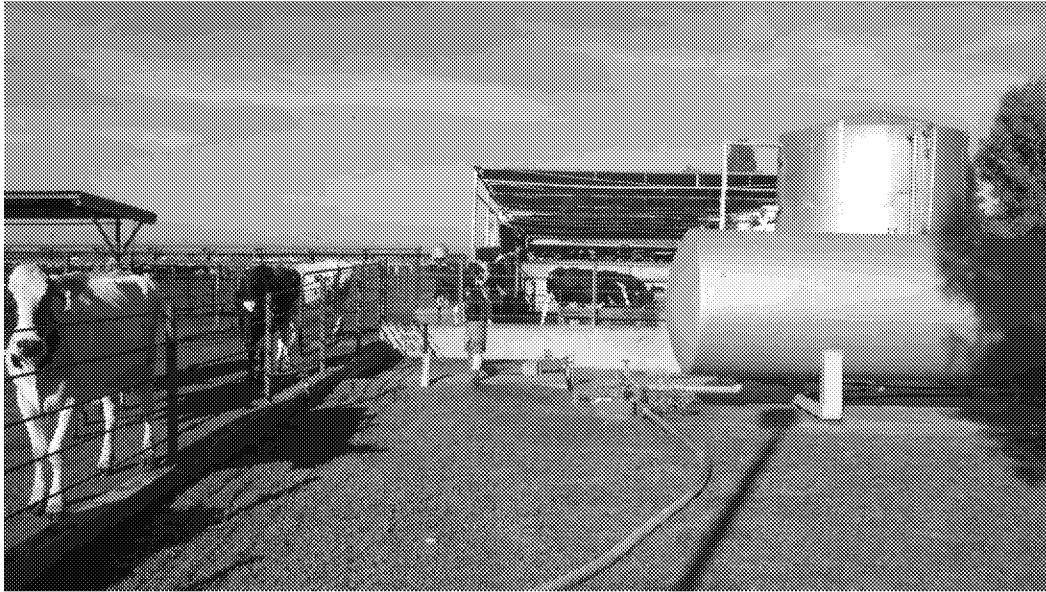
Photo 2: Tank Storage of washwater

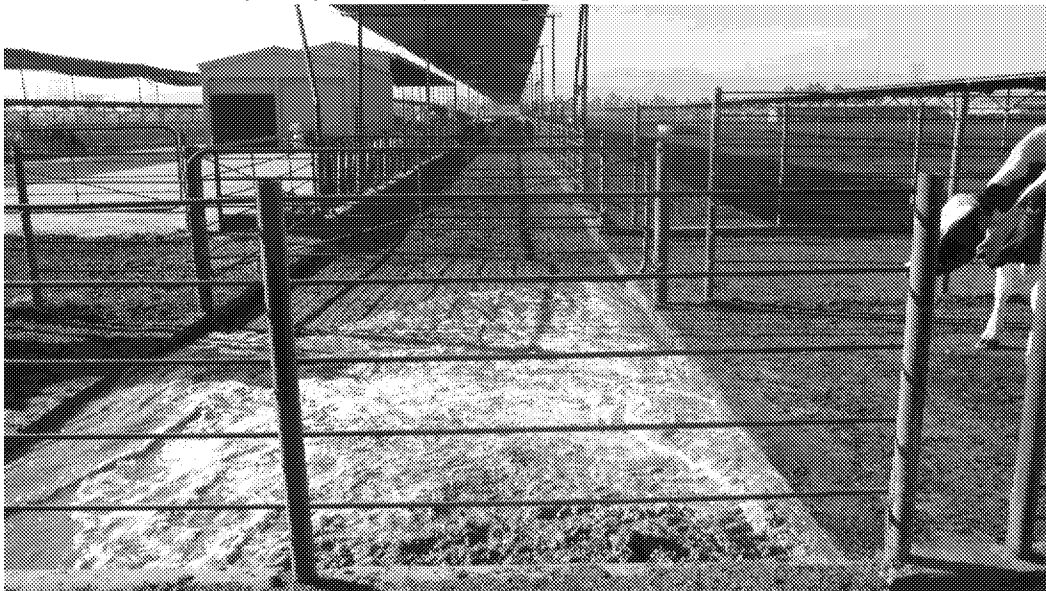
Photo 3: Flush alley in operation, looking south

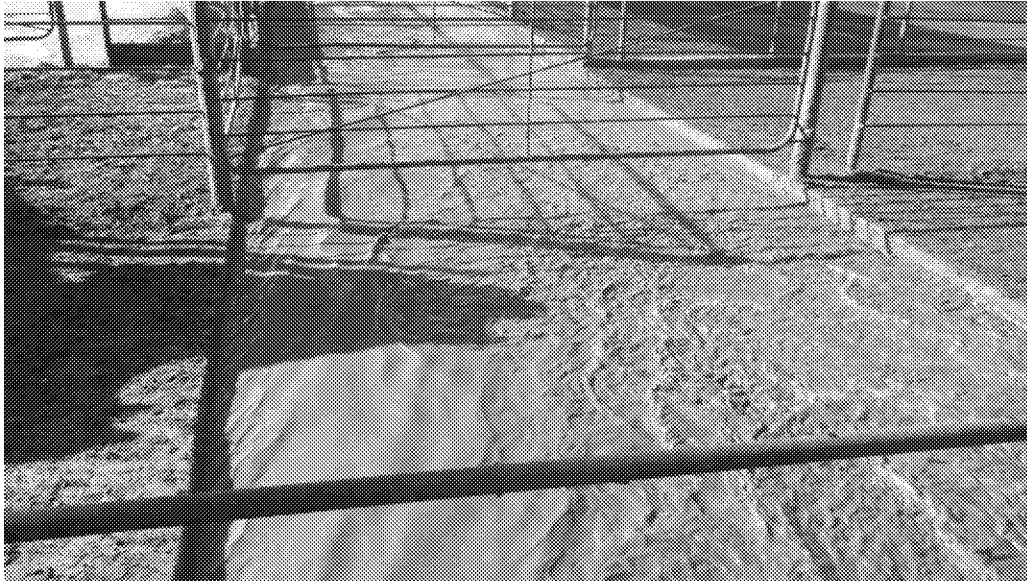
Photo 4: Flush alley

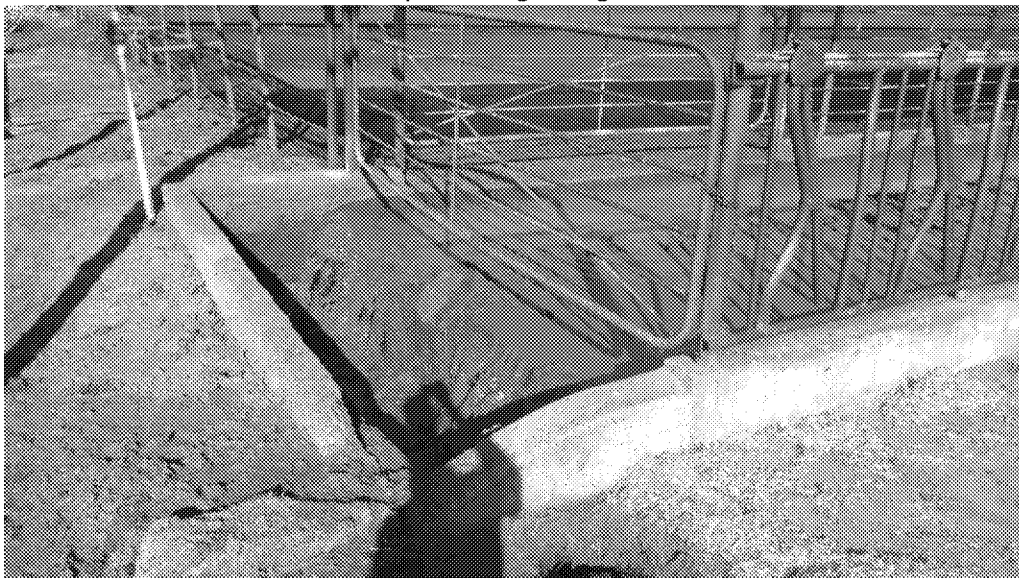
Photo 5: terminus of flush alley draining to lagoon

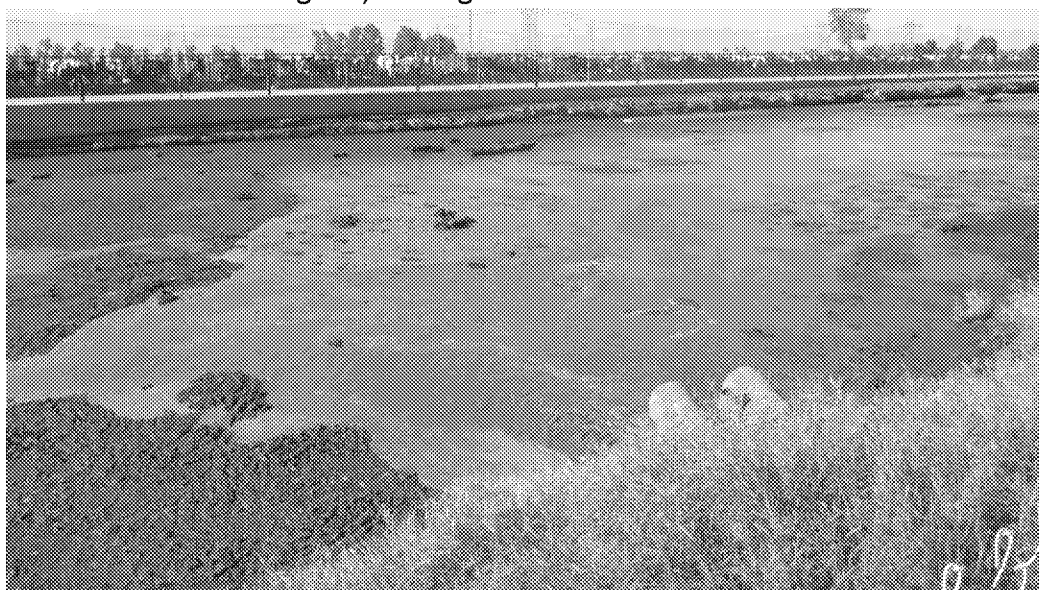
Photo 6: Treatment Lagoon, looking south

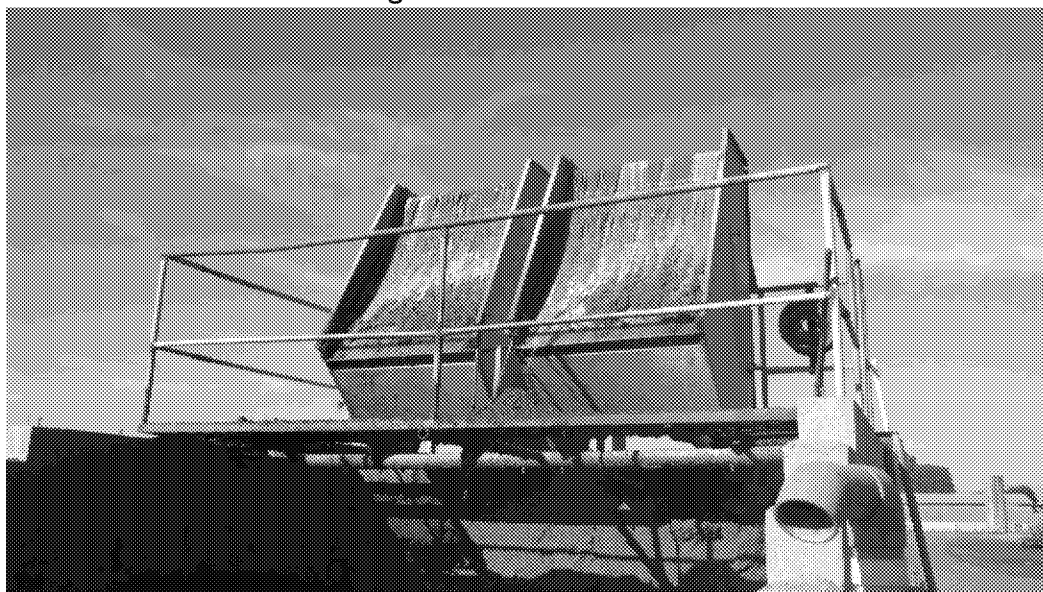
Photo 7: mechanical screening of solids

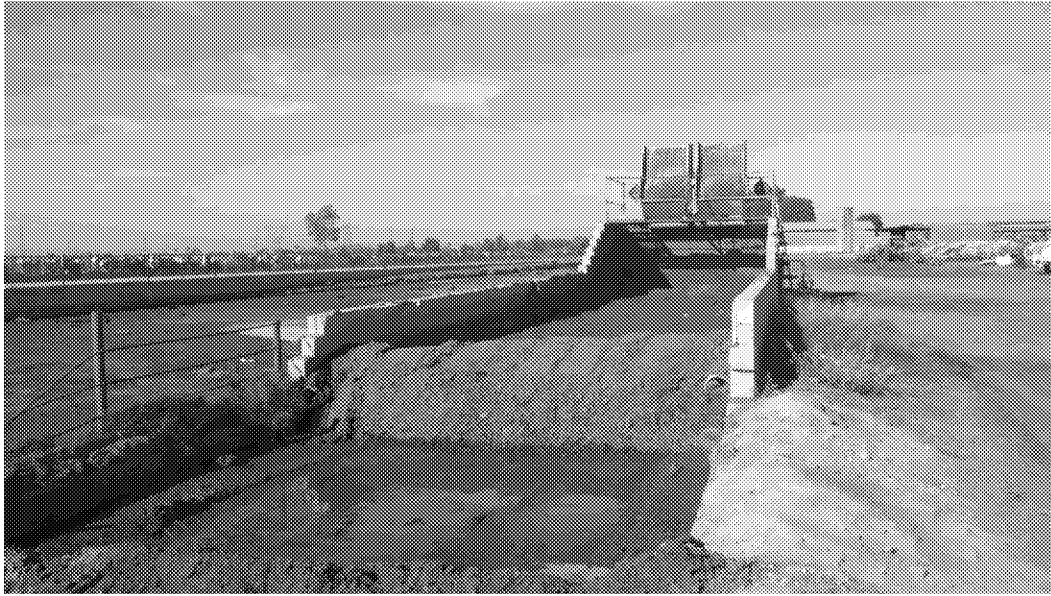
Photo 8: mechanical screening of solids and solids decanting.

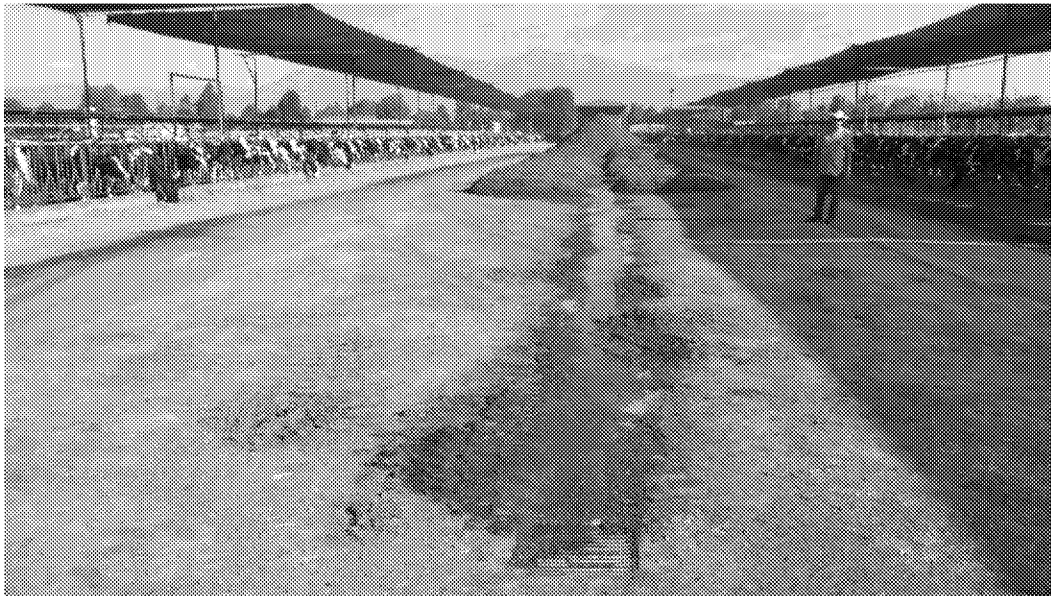
Photo 9: solids storage after removal from decant bin

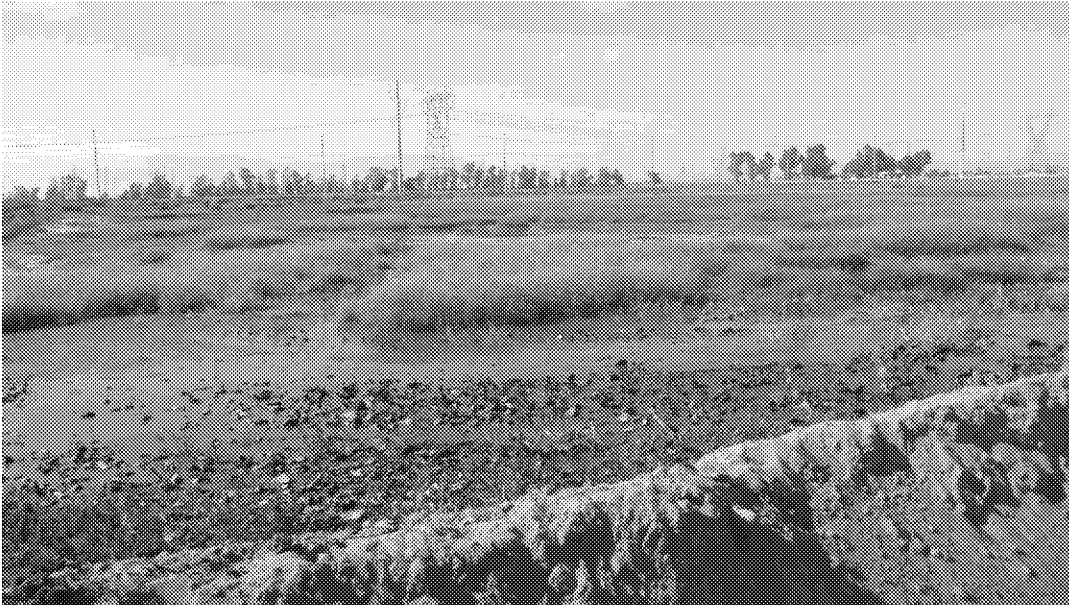
Water decanted from the lagoon is pumped to one of two bermed disposal areas in the south eastern area of the facility (photo 10). The operator alternates disposal to the bermed areas. When one area becomes full of solids, the operator will send washwater to the other bermed area while the operator removes solids and then disks the area to promote infiltration.

Photo 10: Bermed disposal area in southeast corner of facility

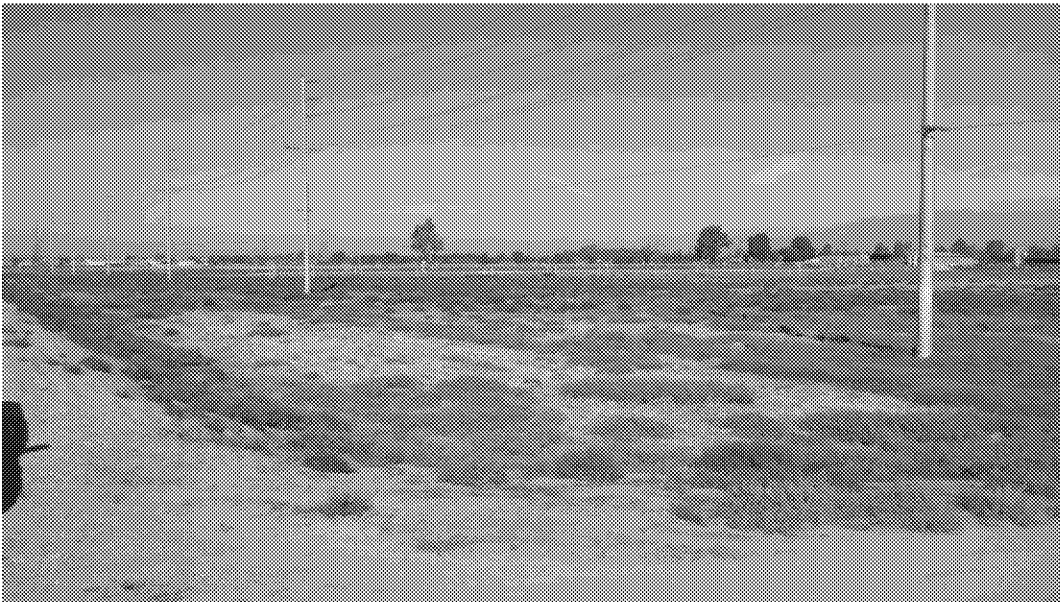
Photo 11: pasture area, berm along southern end of property looking northwest from spillway.

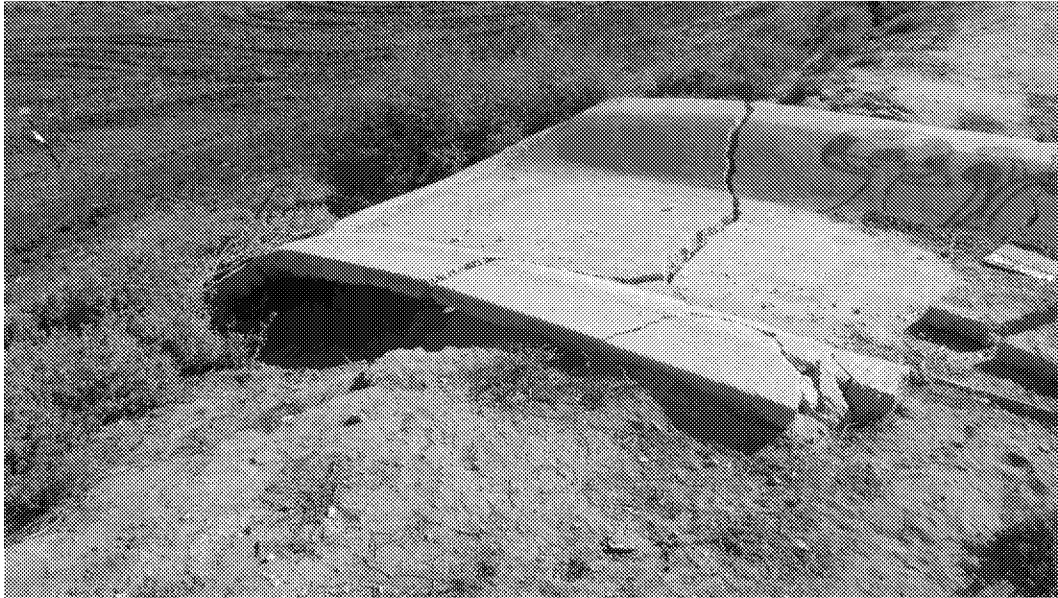
- The spillway was severely cracked and subject to undercutting erosion.

Spillway concrete was severely cracked and undercut due to erosion.

- The spillway was not properly maintained

Photo 12: concrete spillway in disrepair

If not, list structures missing or deficient: Spillway in need of repair.

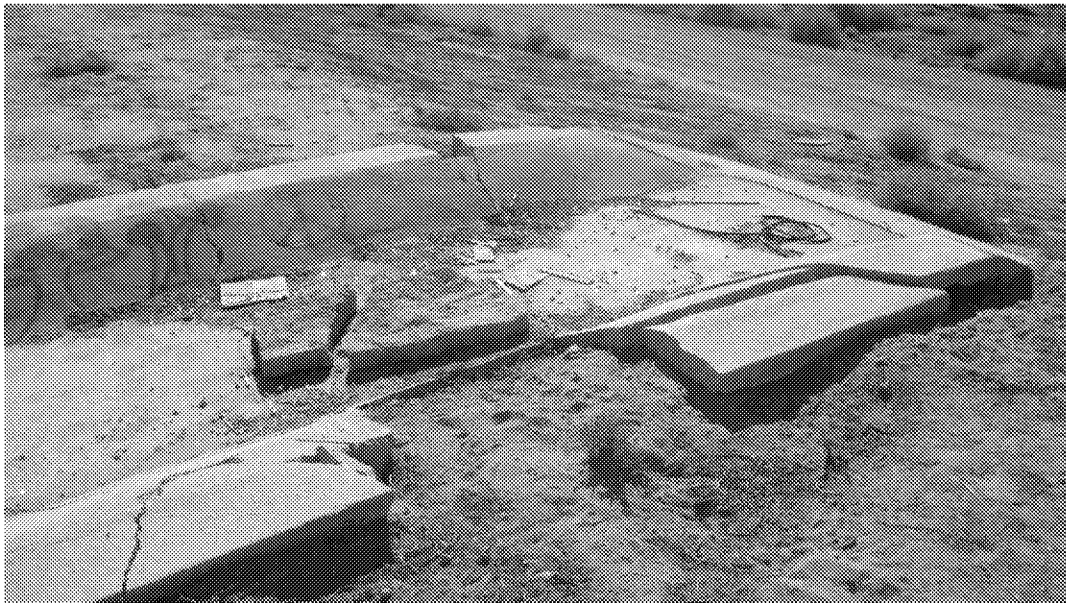
Photo 13: Spillway

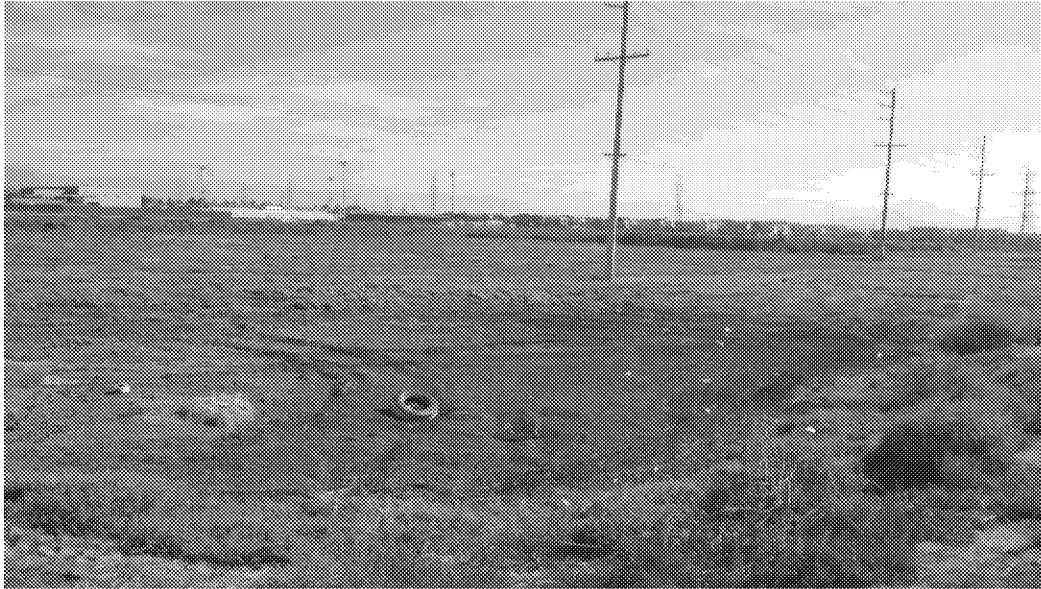
Photo 14: Pasture area looking northeast from spillway.
